## SERVICE BULLETIN

N° **169-148**

# EMERGENCY ALERT

**ATA 64 - TAIL ROTOR FLIGHT CONTROL IMPROVED PERIODICAL INSPECTION**

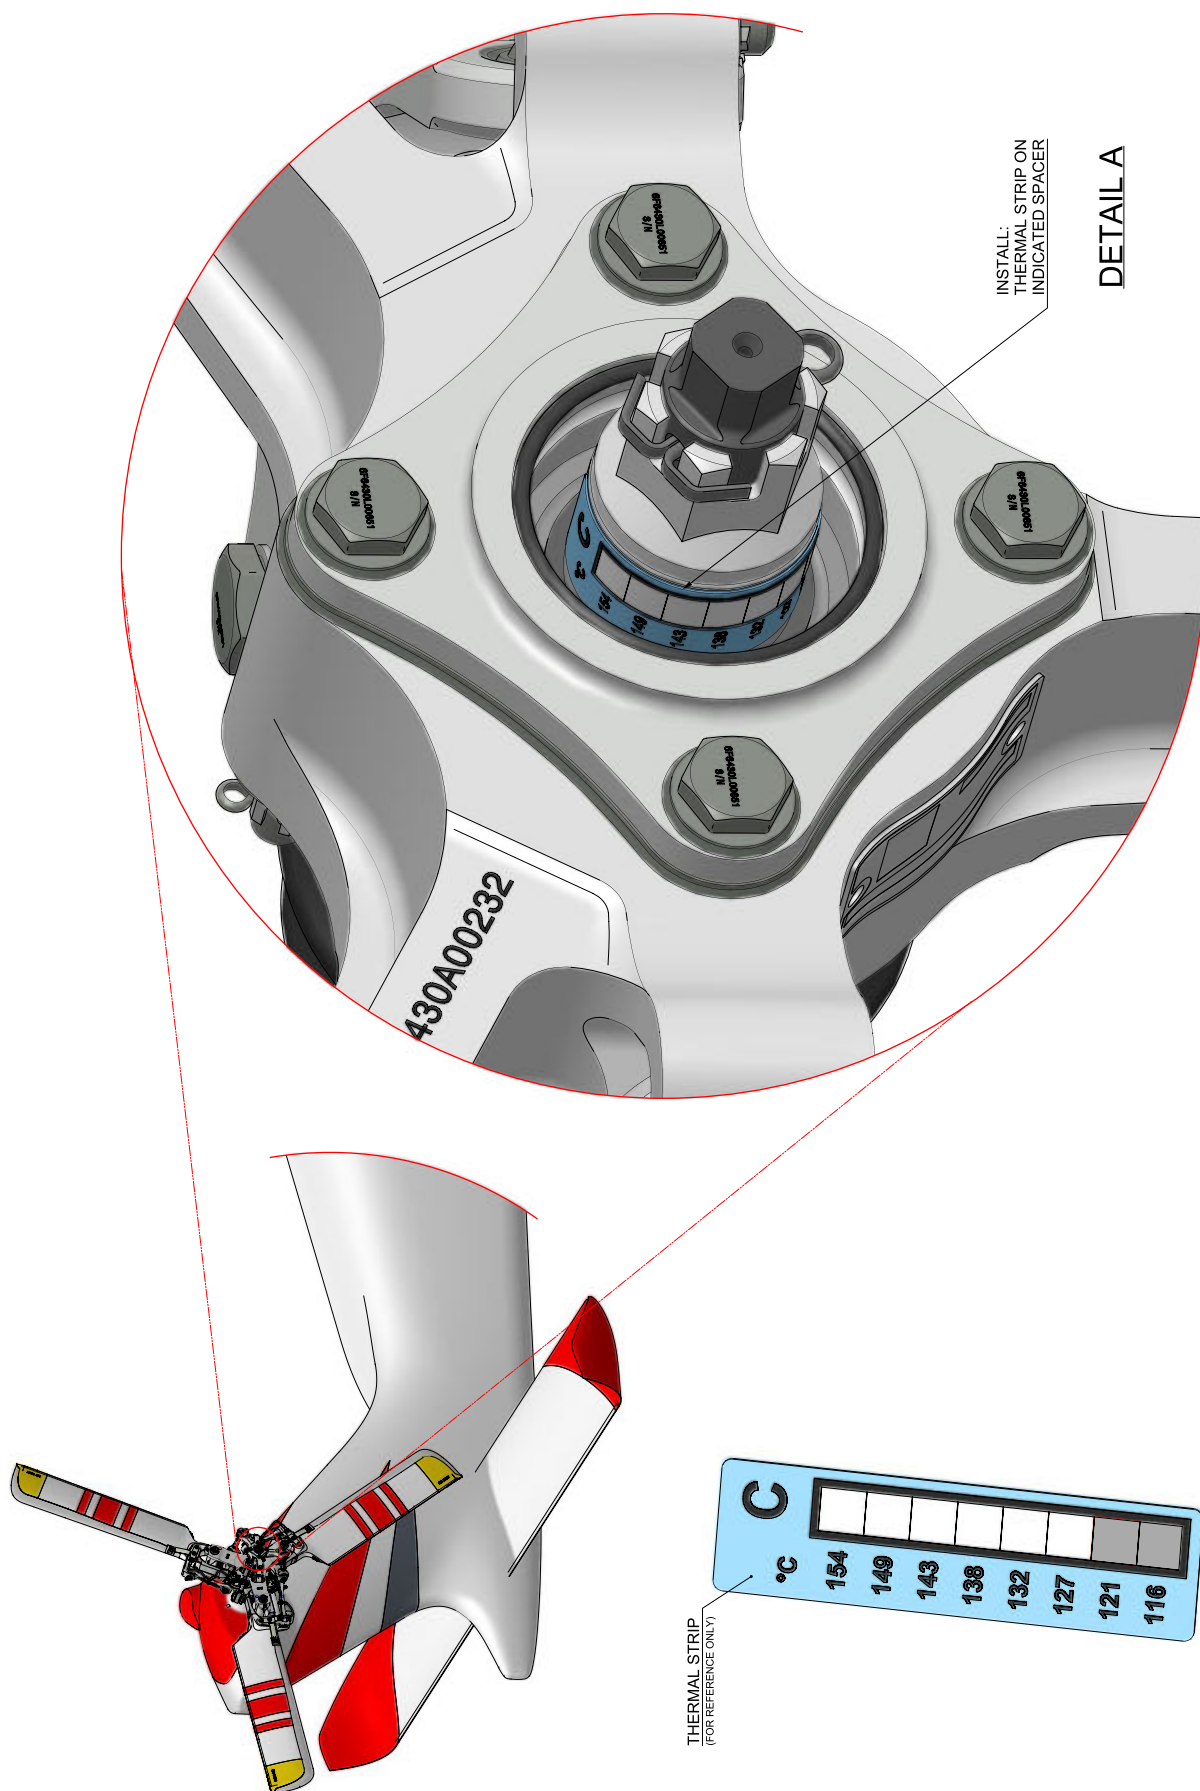
**Figure 4**

4. With reference to Figure 4, check the temperature reached by the thermal strip installed on spacer control rod P/N 4F6430A02551. Make sure that the temperature has not reached a value equal to or above 121°C. Record the check result on Table III (refer to Figure 9).

- 3.3 With reference to Figure 4, with the help of a non metallic spatula, perform the installation of the thermal strip on the surface of the spacer control rod P/N 4F6430A02551.

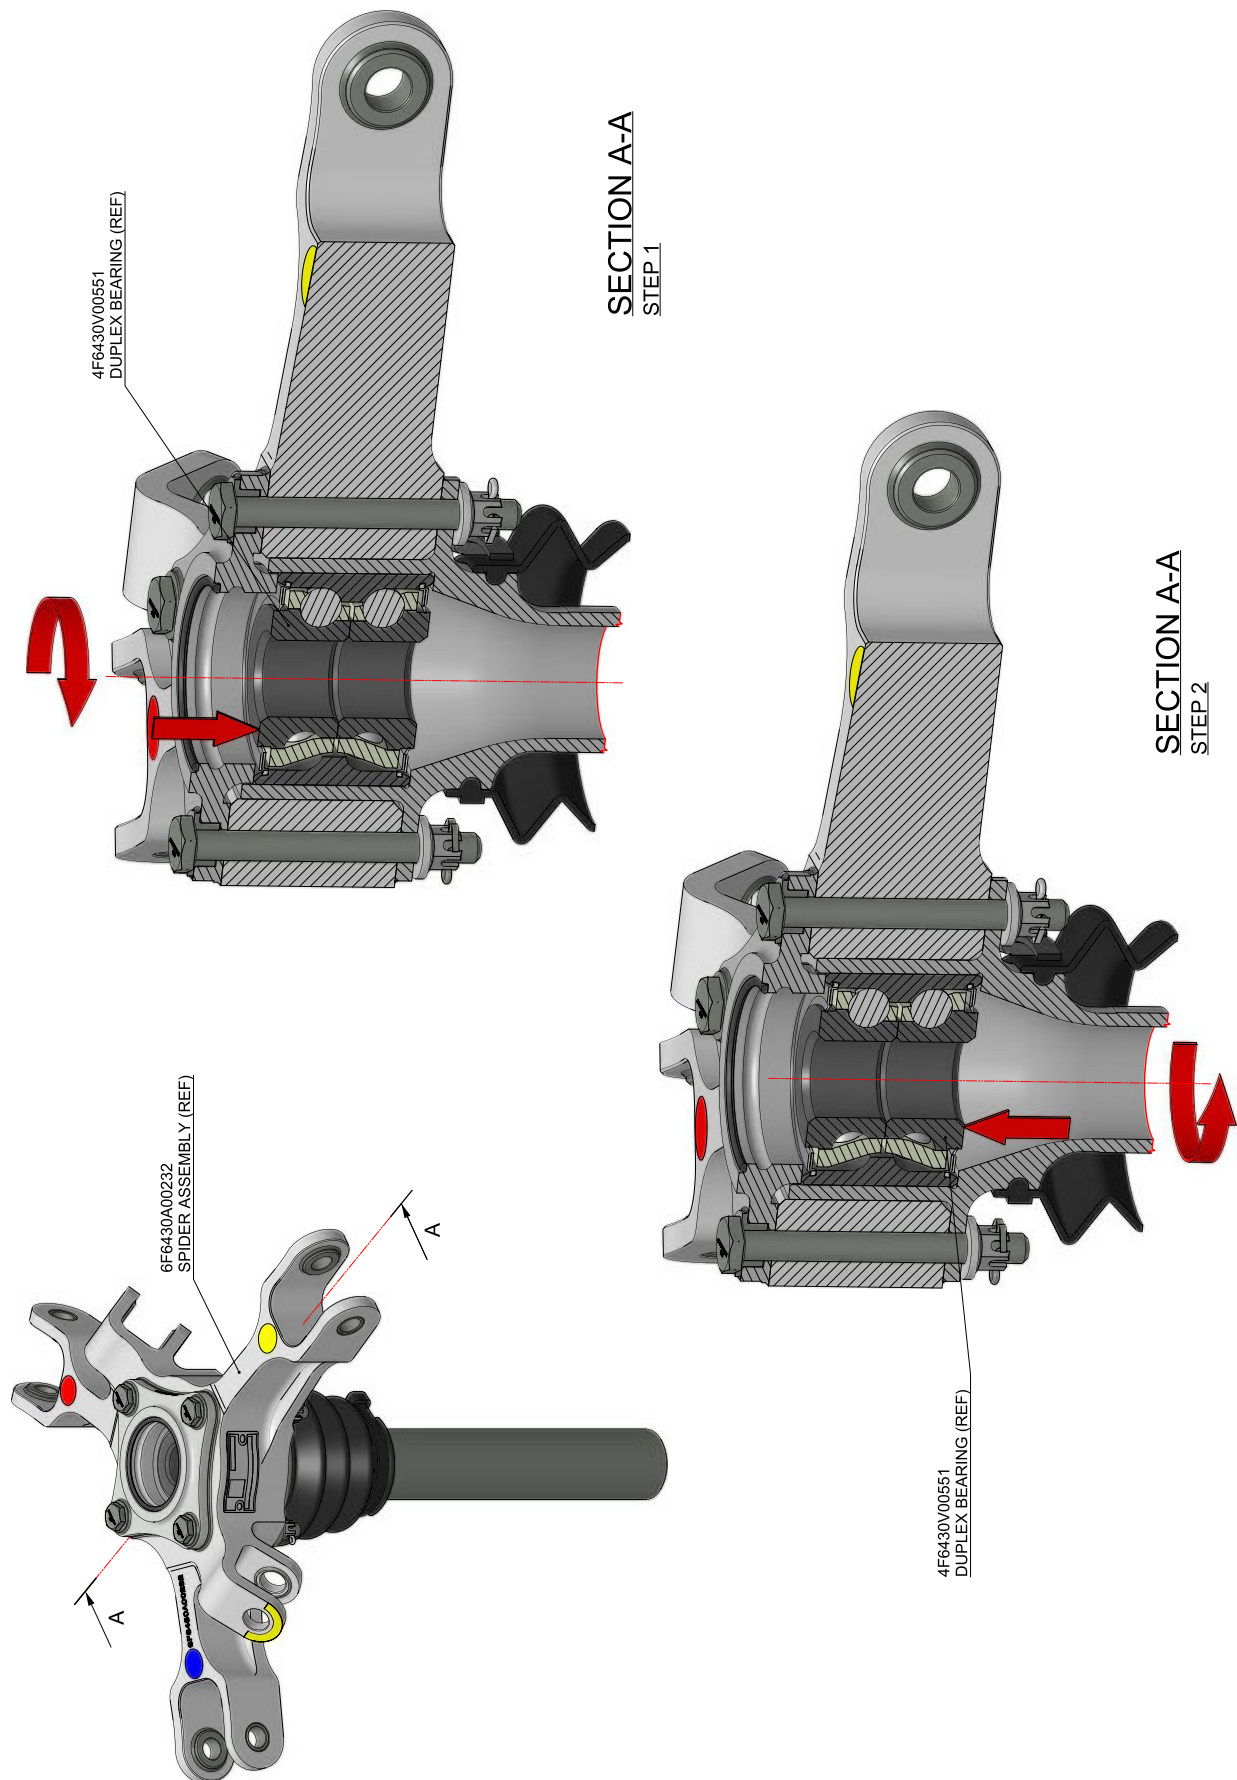
**Figure 6**

- 5.2 With reference to Figure 6 section A-A Step 1, push the top inner race down and at the same time turn it to feel if there is roughness.
- 5.3 Put your finger into the duplex bearing until you can pull up the lower face of the inner race.

- 5.4 With reference to Figure 6 section A-A Step 2, pull the bottom inner race in the up direction and at the same time turn it to feel if there is roughness.
- 5.5 Repeat the Step 5.1 thru Step 5.4 at least one time to confirm the results.
- 5.6 Record the results of the previous steps on Table V (refer to Figure 11).
